# Kitchen Fire

Back Open In 48 Hours

Wednesday, October 15, 2014

Century Services

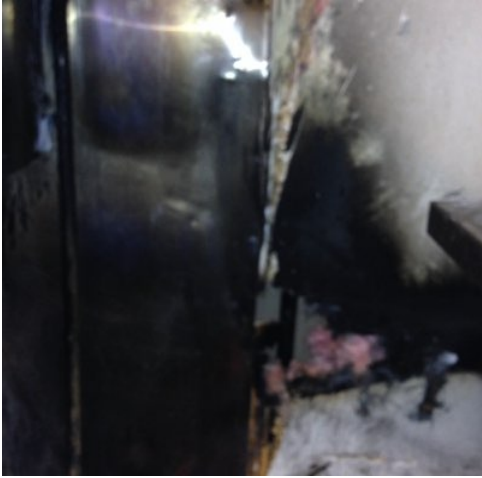
### Photo 1

Small fire behind flattop.

Fire department chopped through wall to insure fire did not hide from them.

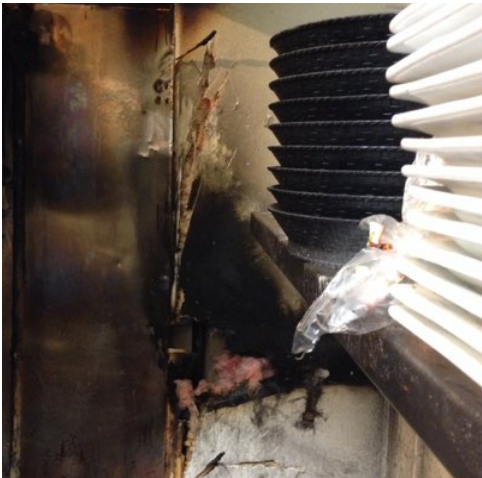
### Photo 2

Another view of effected area.

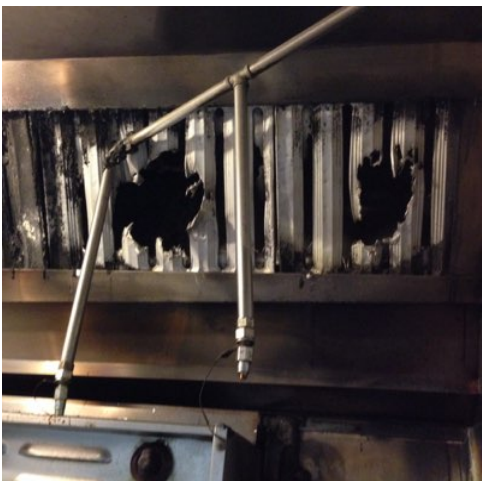
### Photo 3

The fire was pretty hot.

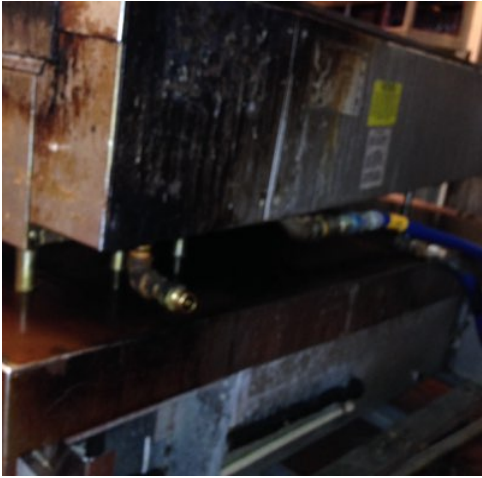
### Photo 4

The gas flex hose was leaking. This is where the fire started.

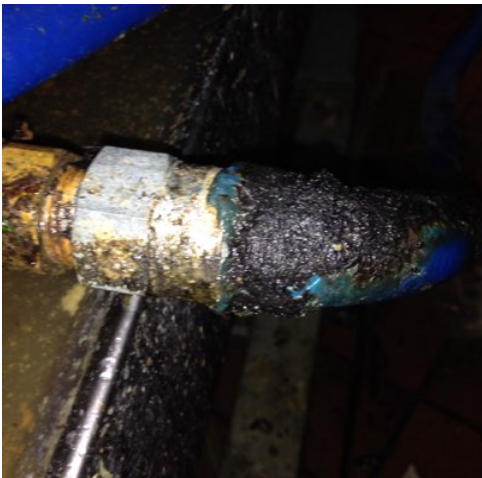
### Photo 5

The guilty party! Gas flex leaked and started the fire.

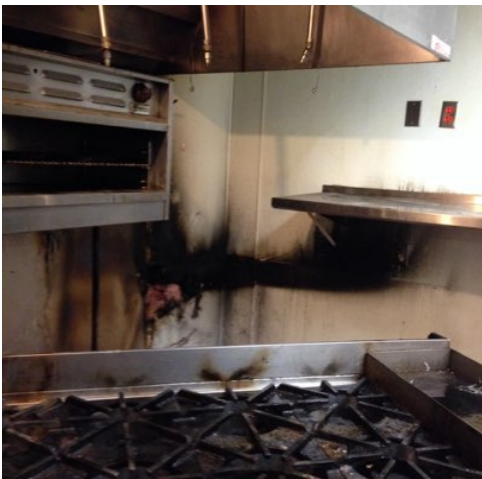
### Photo 6

Flames ran under table and escaped up under shelf.

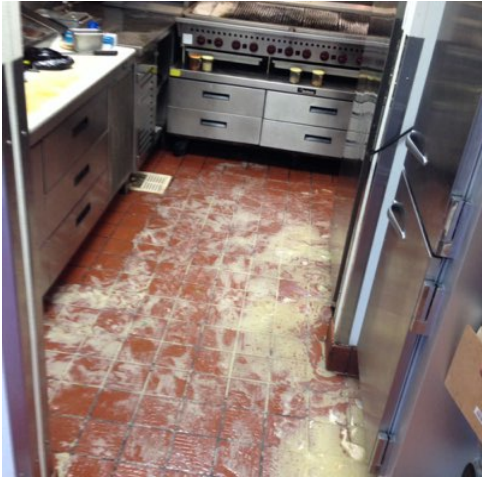
**Photo 7**

**Ansul dumped.**

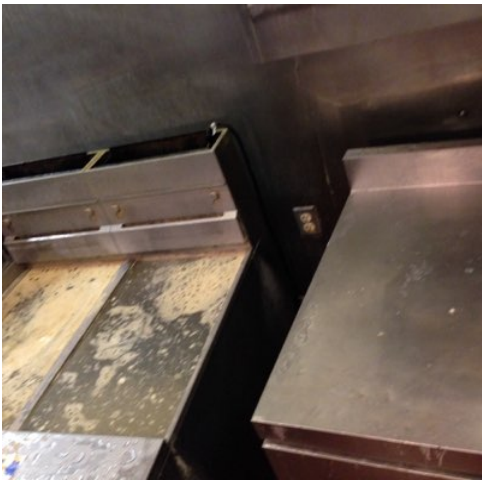
**Photo 8**

**Ansul dumps and makes a huge mess.**

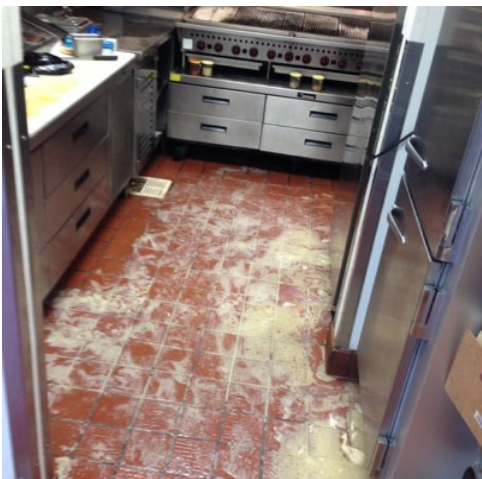
**Photo 9**

**More of the mess.**

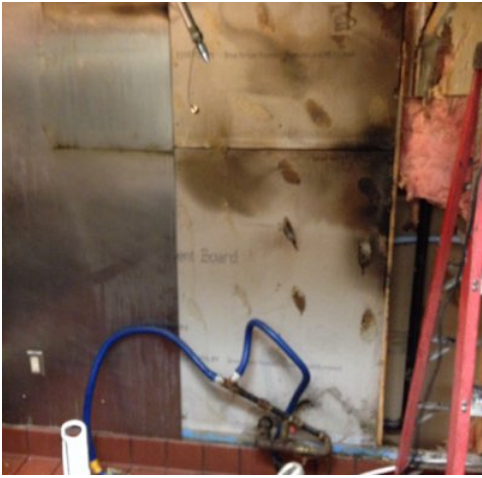
### Photo 10

Started defacing the damaged wall searching for damage.

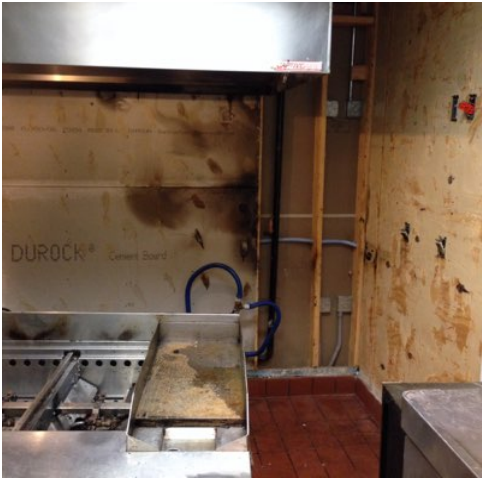
### Photo 13

Wall opened up and defaced. No damage inside wall.

Have to get inspection before closing up wall.

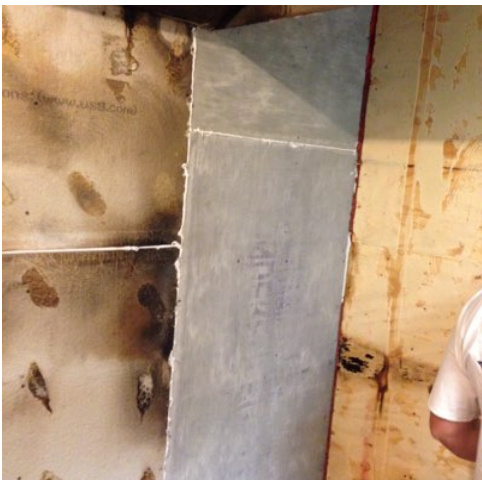
### Photo 14

Got the approval to close up the wall.

Replaced the plywood with concrete board. Fire caulked all seams and openings in wall.

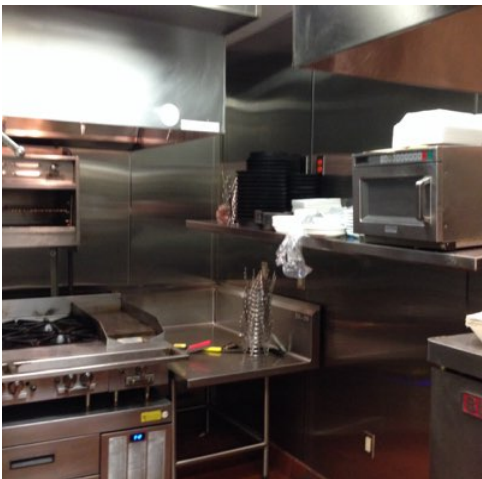
## Photo 18

Passed inspection. Finish setting equipment in place. Store ready to open.

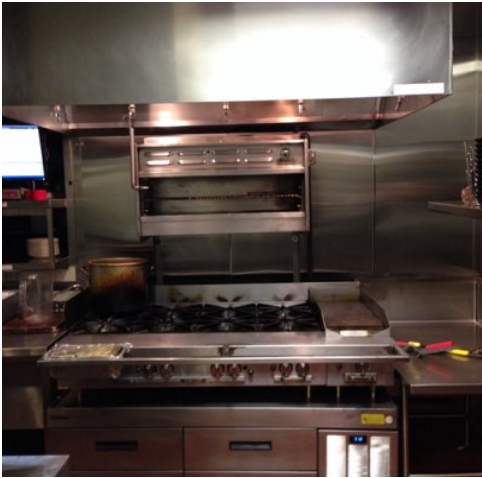
**Photo 19**

**Job complete, store ready to open.**
