# FRIDAY'S 807 DFW C30

Repair Wall Under Hood And Fire Proof

Thursday, July 10, 2014

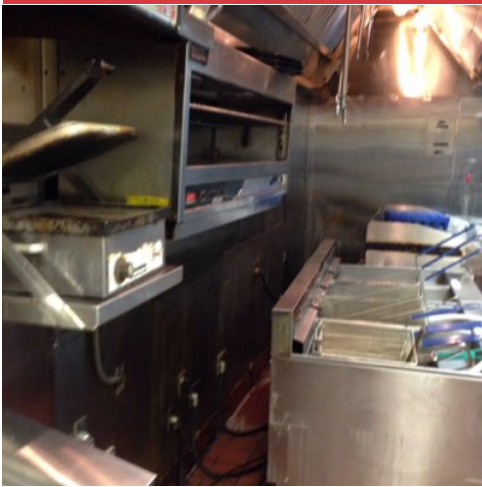
### PHOTO 1

Before:

Cheese melter is pulling away from wall. Cooks having hard time keeping plates on shelf.

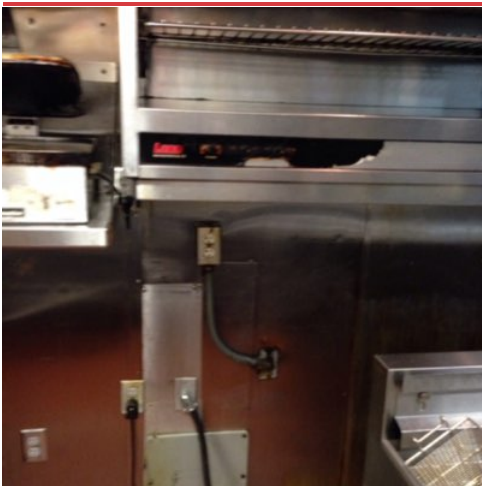
### PHOTO 2

Stainless wall panel has been patched over the years.

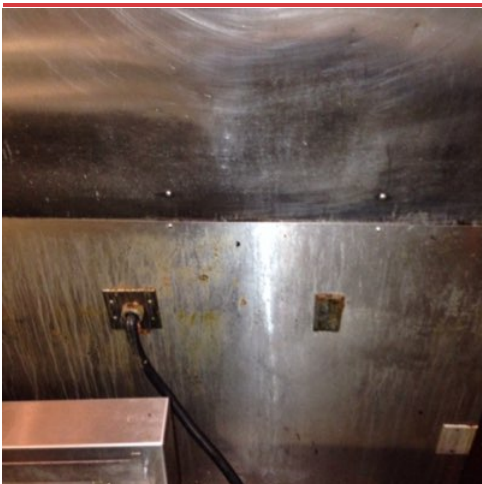
### PHOTO 3

More patchwork stainless.

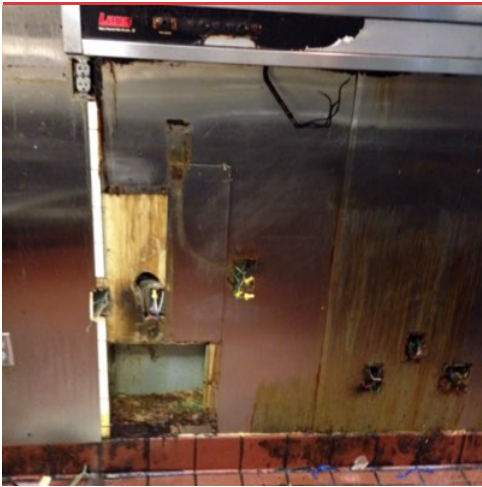
**PHOTO 4**

Another "Before" photo.

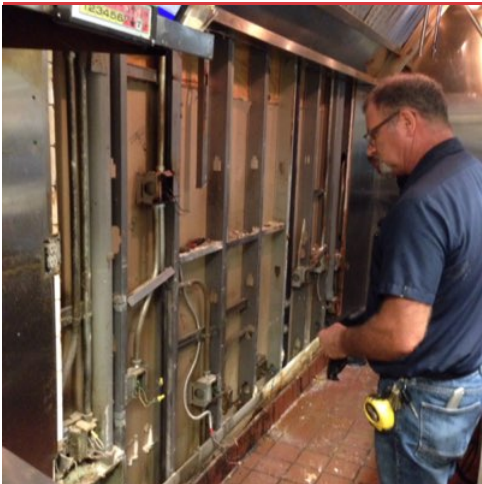
**PHOTO 5**

All the old stainless and Sheetrock off.

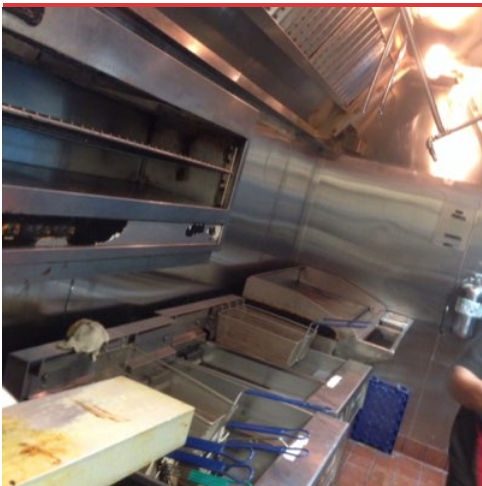
**PHOTO 12**

Everything back in place and ready to start another day!

Only safer!!
