Friday's DFW E-17

Water Leak Through Floor

Wednesday, December 10, 2014

Mickey Perritt
Century Services

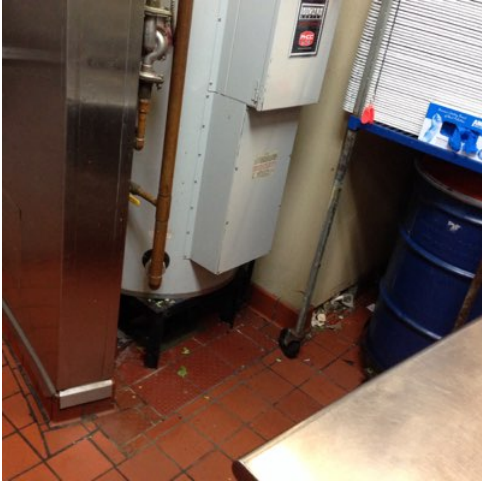
Photo 1

Water leak below floor is coming through two (2) pipe penetrations in the wall to the right of the water heater.

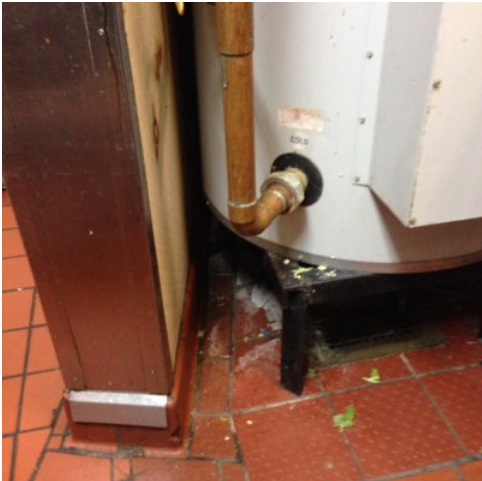
Photo 2

There is some standing water along wall under the water heater. The grout is low under the water heater but we cannot reach it to regroup it.

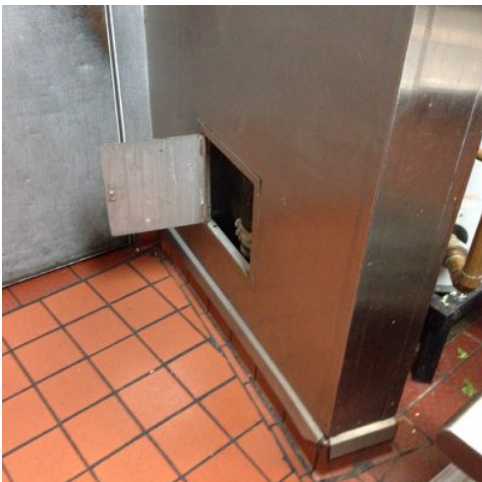
Photo 3

The water in the wall track can be seen in the access door.

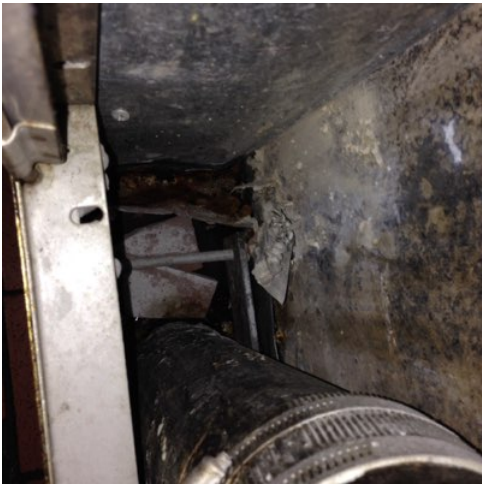
Photo 4

Looking down inside the wall through the access door you can see about 1/4" to 1/2" of standing water.

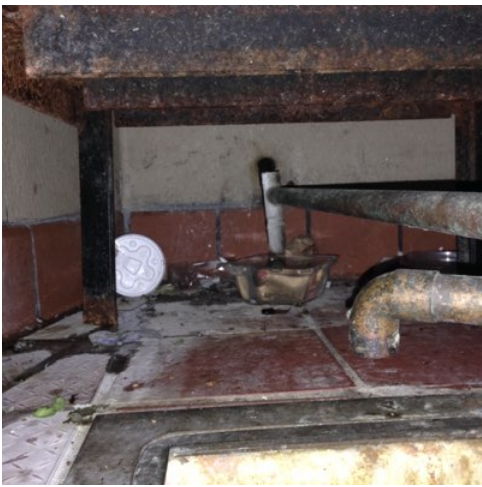
Photo 5

There is a little standing water in the grout joints under the water heater.

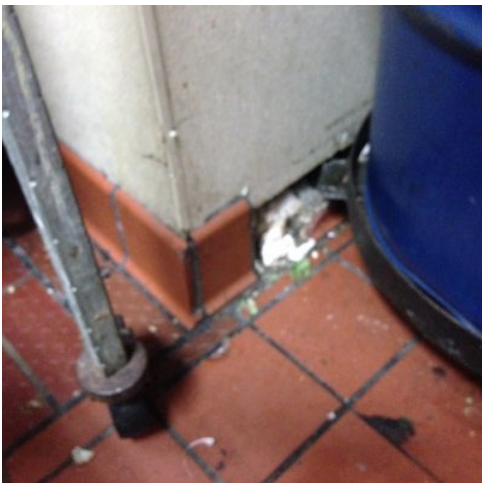
Photo 6

The wall adjacent to the water heater where the grease barrels are kept has most of the base tile broke out of the wall. This is about 5' of wall.

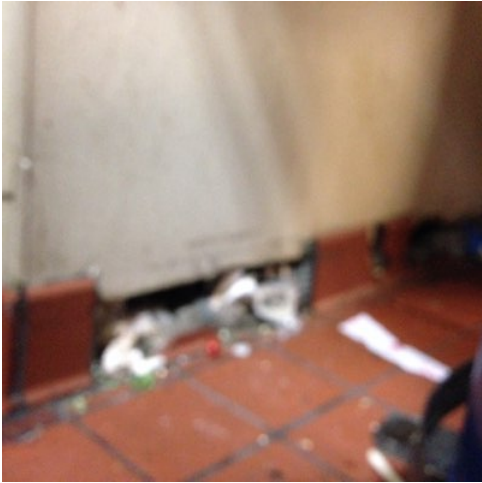
Photo 7

More of the damaged wall behind the grease barrels.

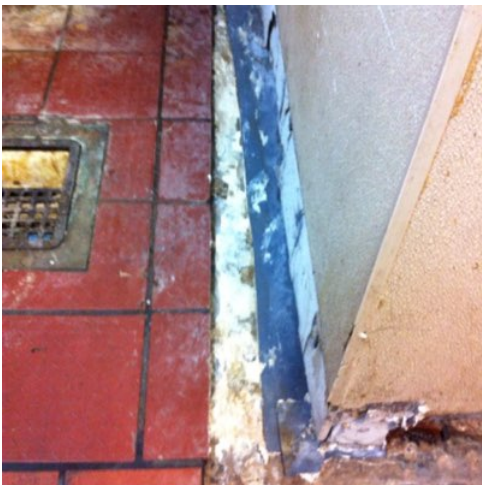
Photo 9

Wall where water was leaking through floor.
