WALK IN COOLER FLOOR REPLACEMENT.

Wednesday, June 4, 2014

Mickey Perritt
Century Services

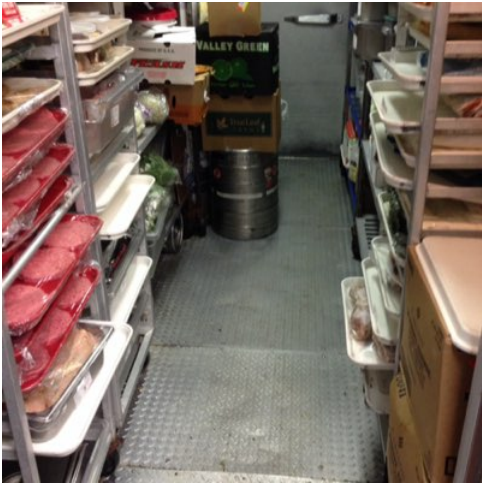
Photo 1

The before. Floor damaged by beer kegs being dropped on it.

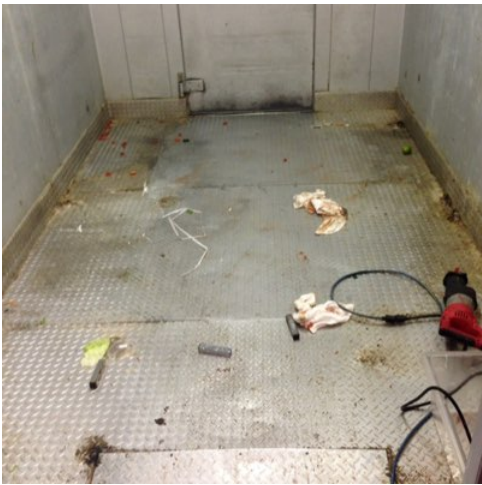
Photo 2

All empty, let's get this thing out of here.

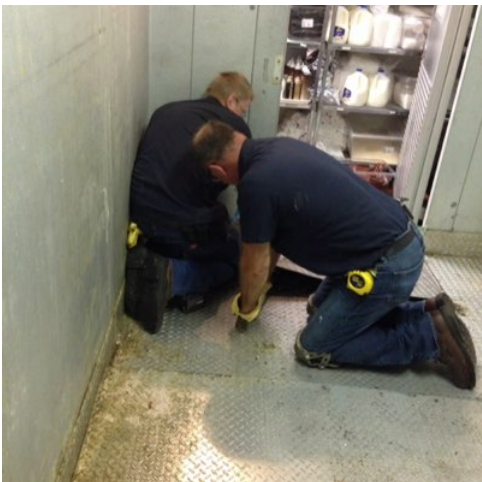
Photo 3

Pulling old floor.

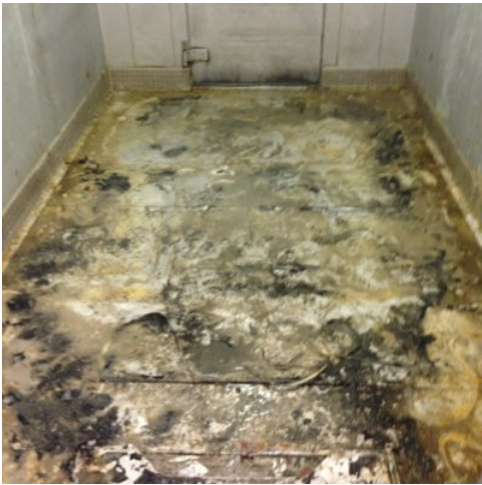
Photo 4

Old floor out. Now let's get this cleaned up and sanitized.

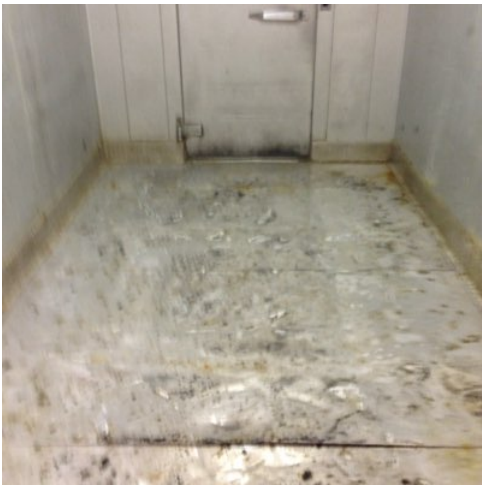
Photo 5

Alright, cleaned up! Now let's get the new floor down.

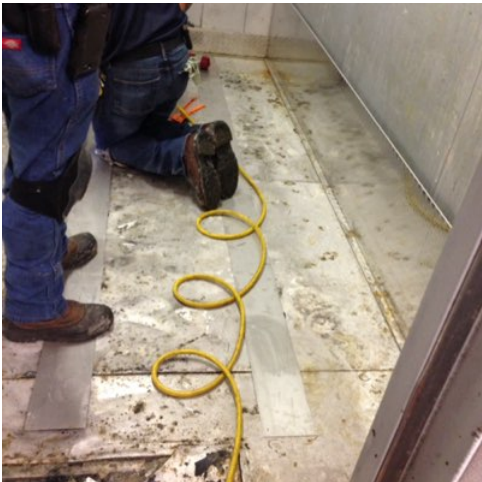
Photo 6

Installing 16 ga stainless steel strips. Set with polyurethane and pop rivets.

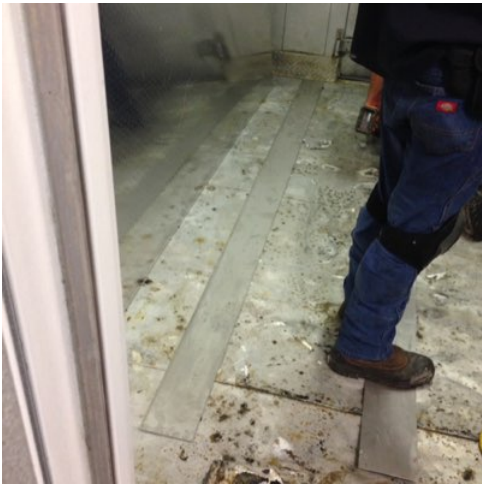
Photo 7

More strips.

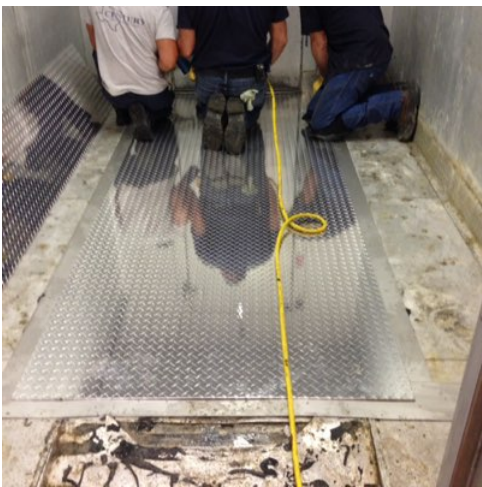
Photo 8

New 3/16" diamond plate set on strips with polyurethane to keep water and moisture out from under floor. Secured with stainless steel pop rivets.

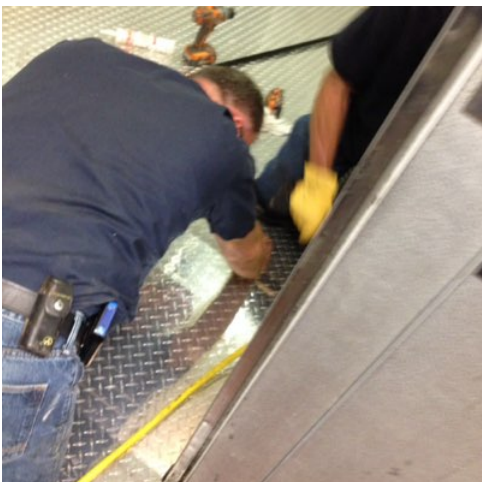
Photo 9

Securing new floor.

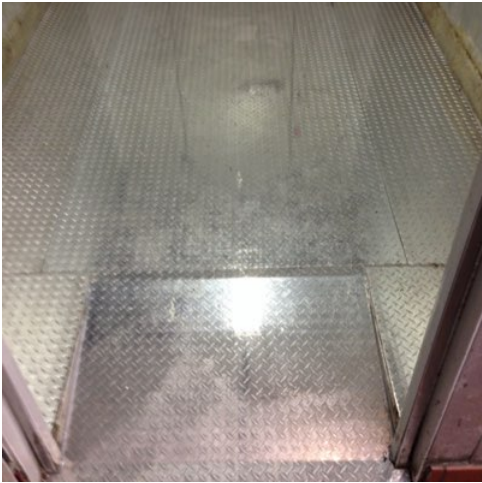
Photo 10

New floor in. Seams kept under shelves to minimize seams in walk area.

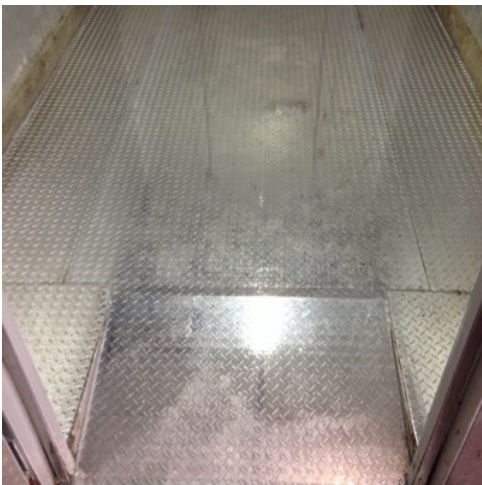
Photo 11

Finished floor.

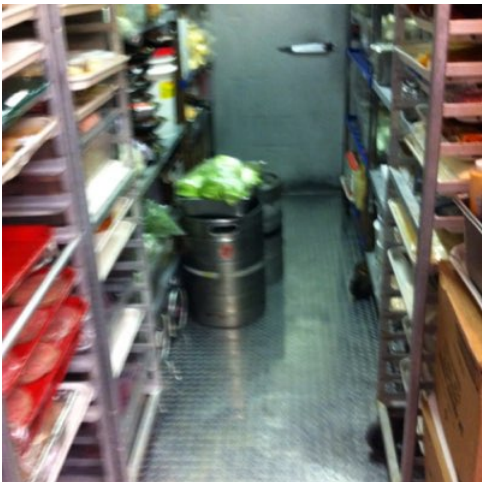
Photo 12

Everything back in the walk in.
